**RISKS OF SANITATION FACILITIES TO GROUNDWATER
POLLUTION IN BABATI TOWN, TANZANIA**

**A Dissertation Submitted in Partial Fulfillment of the Requirements for the Degree of
Master's in Environmental Science and Engineering of the Nelson Mandela African
Institution of Science and Technology**

Arusha, Tanzania

March, 2019

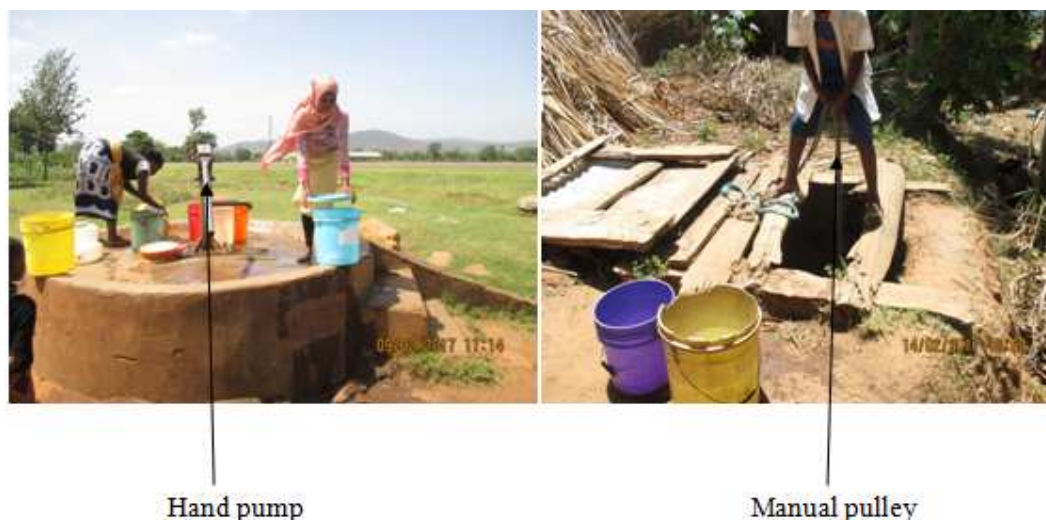
Figure 2: Wells showing the methods of water collection from the source

The classification of the sources was assessed and sampling well groups formulated on their depths and the methods used to draw water. These groups included the shallow wells below 30 m and boreholes above 30 m, in which electric/hand pump was used to extract and those buckets used (Fig. 2).

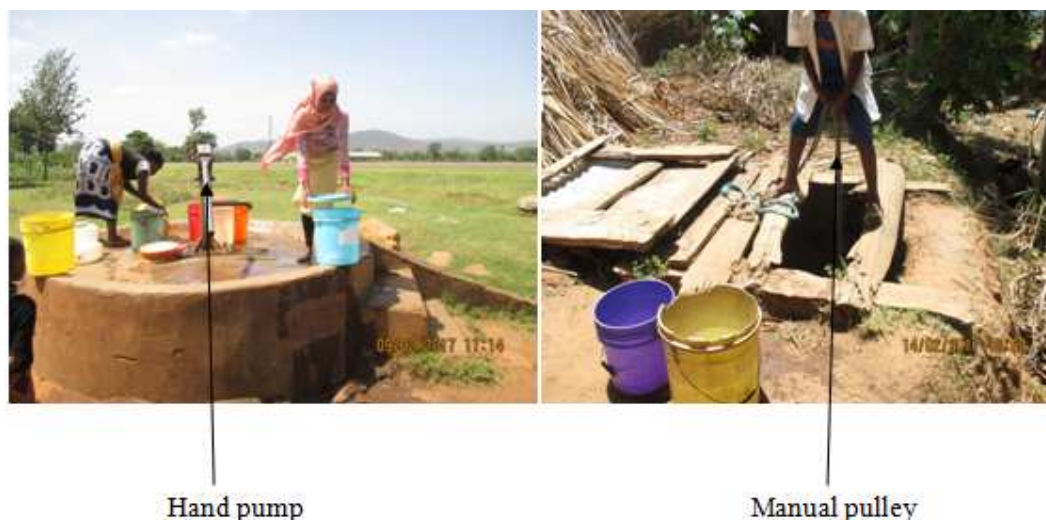
Figure 7: Hand pump and Manual water collection methods

Of all the water sources identified, 389 (89%) were privately owned, at homes or places like hotels, and the rest were community wells, some of which were operated by BAWASA or village/street communities. Various abstraction methods were used including electric or hand pumps, and manually operated rope and bucket systems, the latter type comprising 277 (62%) of sources. BAWASA boreholes were dominant in Babati (6), Bagara (5) and Nangara (4) wards as compared with others (Fig. 8). Boreholes were all operated by the aid of pumps to draw water from the source (Fig. 7).

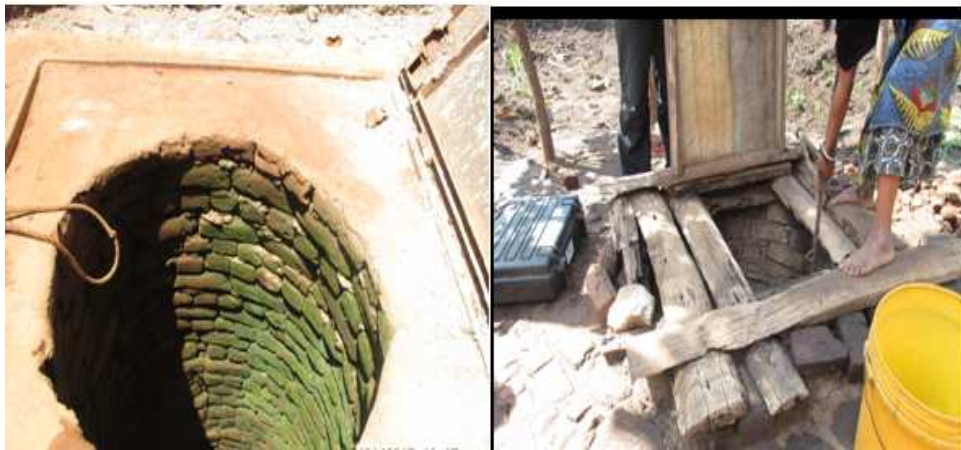
Figure 11: Well unlined and with inadequate cover

The results for groundwater sources and contamination pathways and for surface water and spring sources management status are shown in Table 4 and Table 5 above. Based on the results about 19% (81) of the well were uncovered and or had inadequate hygiene covers and 70% were unlined (Fig. 11). Municipal faecal sludge disposal was done in inadequate area designated in Maisaka. This was due to have un-existing municipal waste water collected pipe/sewer and treatment site. The dominated water collection methods from the wells were pumps and manually operated rope and bucket (62%) systems. Pollution of water sources from nearby pollution sources in association with inadequate waste disposal of human wastes/fecal origin or manure have been reported to exist in some cases (WHO, 2008) . In

these cases the pollution detected in well water were linked with manure from the nearby farm facilitated by rainwater intrusion and nearby pit latrines respectively. The findings of all wells uncovered and/or un-lined together with the current practiced well sitting near the toilets, their shallowness and inadequate water collection methods are increasing the risks of groundwater contamination. The untreated fecal sludge disposed at Maisaka site is also an emerging risk for groundwater contamination because they might be re-transported into the water sources by flowing storm water and or creatures/pets roaming around the dumpsite (Fig. 12). About 12% (51) of sources of wells had a depth of less than 5m and are considered more susceptible for contamination the interaction with nearby toilets raised during rainfall and raised water table or from other contaminants on land surface.

- (i) Further research/study on hydrochemistry of water for better management of groundwater resources and its quality.
- (ii) A strategy to deliver education (knowledge based) to the stakeholders to ensure proper well constructions and appropriate water sources management in rivers and springs to minimize pollutions.
- (iii) Education is needed for people who use and consume water from surface waters sources and private wells on daily basis to treat/disinfect water before drinking
- (iv) The community should avoid the disposal of animal and human faecal into inadequate facilities near groundwater sources.
- (v) Review of the existing regulations to accommodate un-encountered standards for water sources management and to ensure that are into enforcement
